## FAILURE ANALYSIS OF BEARING IN WIND TURBINE GENERATOR GEARBOX

**Abstract-** This research paper describes the failure analysis of bearing in Wind Turbine Generator (WTG) gearbox. The two-stage filter element and the gearbox were examined at turbine tower top called nacelle to find out the reason for filter choke alarm in the turbine controller. Drive train alignment was ensured between the asynchronous generator shaft and the gearbox shaft to conclude the mode of bearing failure. The chemical and micro-structure together with hardness measurements were carried out on the failure bearing to check for deviation in the material specifications and heat treatment process. Detailed studies including visual inspection, Scanning Electron Microscope (SEM) and Energy Dispersive Spectrum (EDS) analysis were performed on the damaged bearing surface to determine the root cause(s) for failure. The peak temperature parameter in the gearbox at various places and power of the wind turbine were monitored for any abnormalities in the WTG. The study revealed that an intermediate non-drive end bearing failed in the gearbox due to excessive material removal on the rollers and bearing races due to co

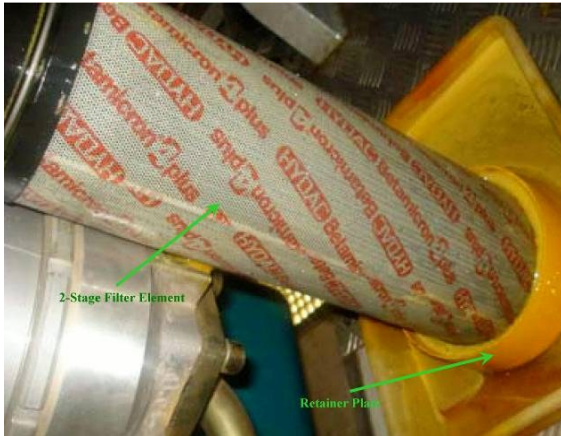
Fig. 3- Choked gear oil filter

There was filter choke alarm in the controller of wind turbine generator on 16<sup>th</sup> August 2010. On thorough scrutinization of the 2-stage (50  $\mu$ m and 10  $\mu$ m) filter element (Fig. 3), enormous metal particles (Fig.4) were traced out in the retainer plate (Fig. 3) located at the bottom of the filter. Immediately, the turbine was stopped for vibration analysis and thorough gearbox inspection to pin point the failure location. From the study, it was concluded that the failed component is an intermediate stage non-drive end bearing (Fig. 5). The persistent running of the gearbox with defective bearing caused damage on intermediate pinion (Fig. 6) due to tooth loading. It was observed from the site feedback that most of the wind turbines require significant repair and even complete overhauls within five to seven years or even before that benchmark as wind turbine downtime is attributed to gearbox related issues. The replacement of gearbox and lubrication attribute to 38% of the cost of turbine parts. Considering the cost of the gearbox, crane rental, labour and revenue loss, replacing a gearbox of 1.0mW to 2.0 mW turbines can cost more than 60 lakhs INR. The bearing failure occurs very often at the non-drive end of the intermediate stage. The main geometric dimensions of the failed bearing (Fig. 7) are listed in Table 3. A team comprising of operation, maintenance and product development engineers has been trying to explore the possibility of designing heavier bearing and employing new bearing manufacturing process for trouble free operation of the wind turbine.

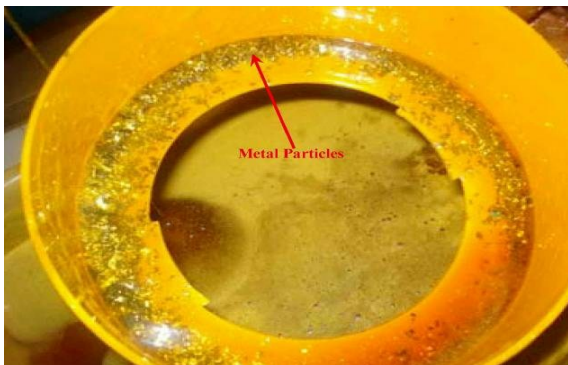
Fig. 4- Metal particles at retainer plate

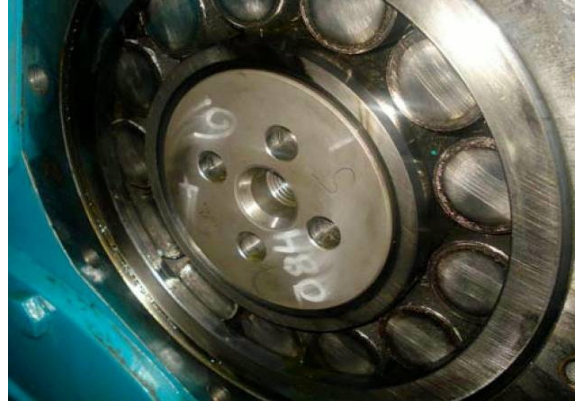
Fig. 5- Failed intermediate non-drive end bearing INA LSL 19 2330 A0993

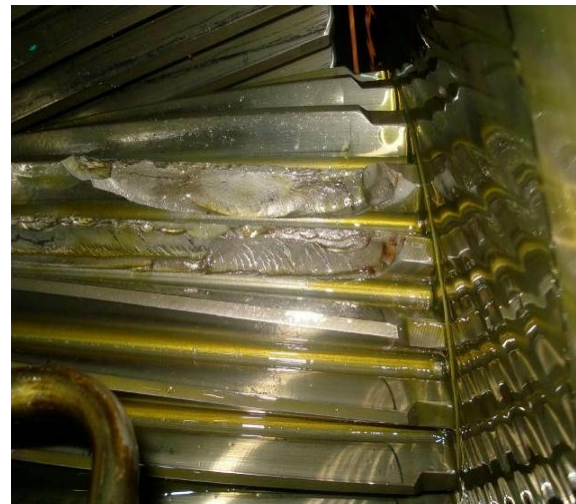
Fig. 6- Damaged intermediate pinion

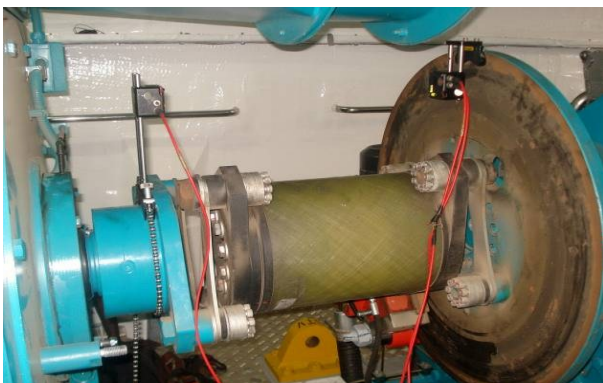
Initially, the position of the asynchronous generator shaft relative to the gearbox shaft was examined through laser-optical alignment technique (Fig. 8) to conclude the mode of failure, as most of the bearing failures in rotating machinery are attributed to misalignment in the drive train components. A vertical offset misalignment of 0.14mm and vertical angular misalignment of 0.12 mm /100 mm were found while inspecting the shaft alignment using easy laser measurement and alignment system. The generator foot positions were 0.07 mm at the front side and -0.16mm at the rear end. Similarly, the horizontal offset misalignment of 0.30mm and horizontal angular misalignment of 0.08 mm/100 mm were noticed. The generator foot positions were 0.22 mm at the front side and -0.39mm at the rear end. According to the maintenance manager, the acceptable limit of horizontal and vertical offset misalignment is 0.10 mm and the angular misalignment is 0.08mm / 100mm and this slight misalignment will not cause any catastrophic effect on the bearing life and on operation of the gearbox. So, it was confirmed from the alignment study that the failure of intermediate non drive end bearing and the pinion is not because of the mis-alignment in the system. Further, the gearbox under consideration is lubricated by mineral oil having a viscosity index of 460 for bearing and gear.

Fig. 8- Drive train alignment in WTG

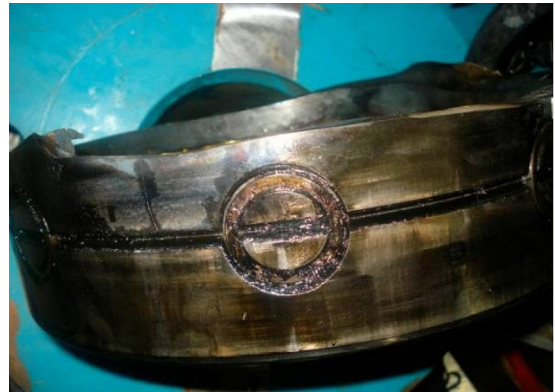
Fig. 12- Damaged outer race of bearing

Surface and sub-surface fatigue wear that is contact fatigue (spalling) at the non drive end of the roller (Fig. 9) on several rollers (Fig. 10) due to overloading and excessive material removal. The same could be seen on both inner races (Fig. 11). The damaged outer race of the bearing is shown in Fig. 12.

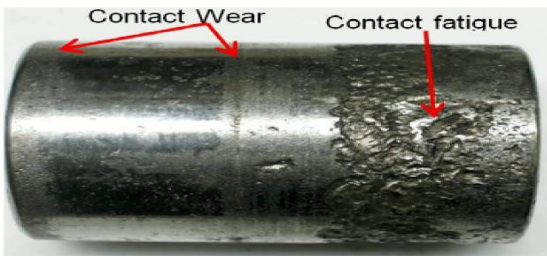
The visual inspection of the roller revealed that scoring lines representing contact wear were observed at the middle and drive end portion of the roller.

Fig. 9- Wear on roller

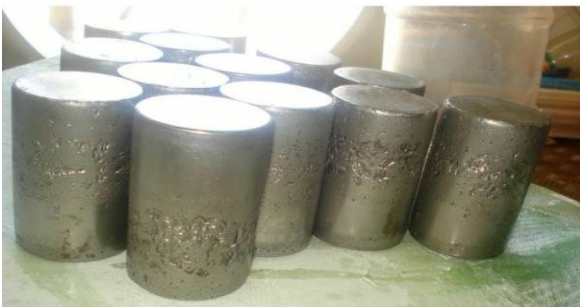
Fig. 10- Damaged roller

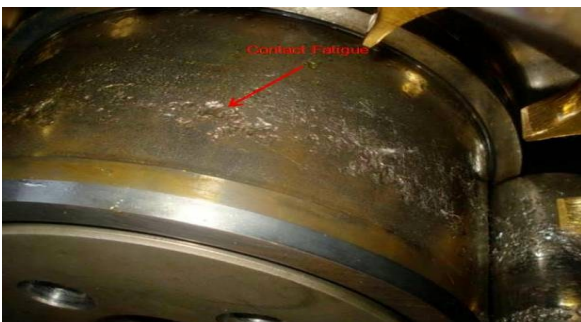
Fig. 11- Wear on inner race

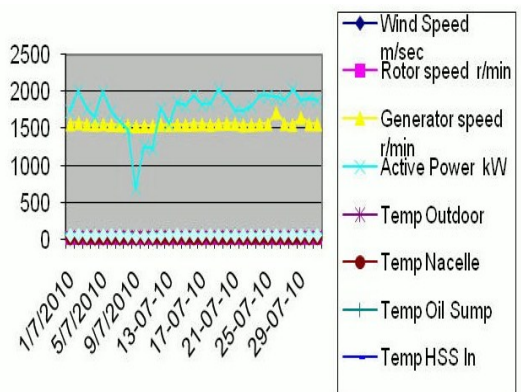
In order to identify the reason for excessive material removal on the rollers and races, the peak temperature and power at which the turbine (last bearing failure location) operated before bearing failure were downloaded from the turbine controller for evaluation. It is obvious from the temperature and power curve (Figs. 13 and 14) that the instant peak power generation of the turbine has gone up to 2024 kW continuously for the last two month (15/07/2010 to 15/08/2010) which is higher than that of the rated power of the gearbox (1250kW). This excess load on the gearbox and frequent change in wind speed caused overloading on the bearing resulting in severe damage.

Fig. 13- Comparison of temperature and power for July 2010

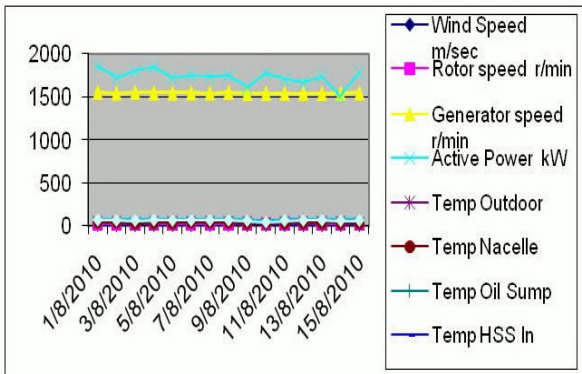
Fig. 14- Comparison of temperature and power for August 2010

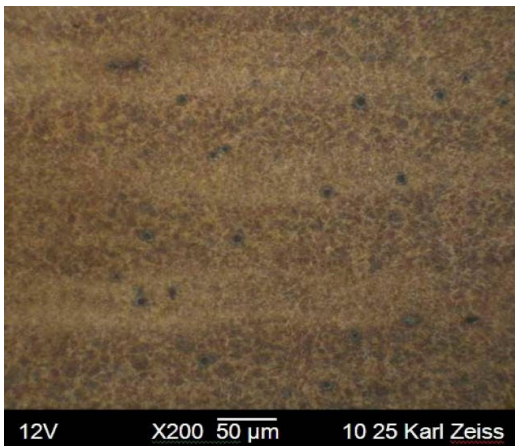
The specimen of failed bearing was prepared by fine polishing preceded by rough and intermediate and then etched with 2% Nital solution for examination. The microstructure of the damaged bearing was analyzed under optical microscope as well as Scanning Electron Microscope (SEM). The photographic view of the microstructure of bearing based on the experimental study is shown in Fig. 15. Tempered martensite structure with fine carbides (Fig.15) is seen on the bearing surface during microstructure examination. The specification of the material includes tempering treatment which was clearly evident from the microstructure examination.

Fig. 15- Micro structure of bearing material. It consists of tempered martensite structure (200x)

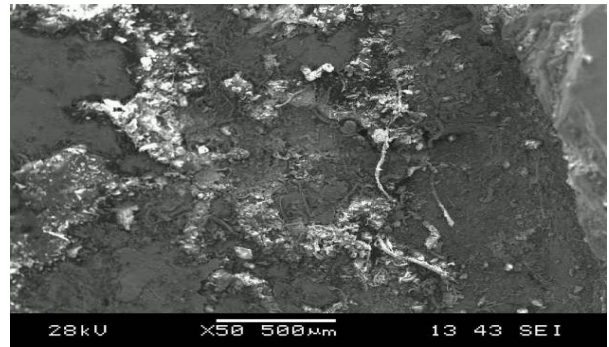
Fig. 16- SEM image of the bearing. Wear debris and corrosion products are seen

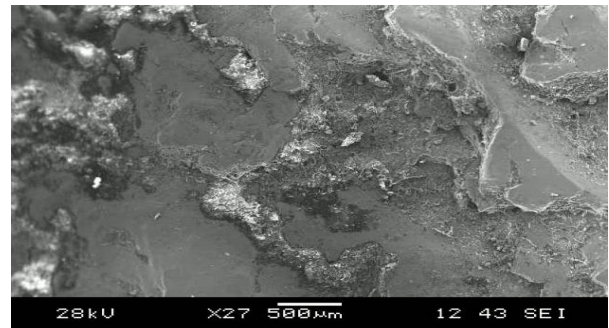
Fig. 17- SEM view of the bearing. Fatigue and cleavage fracture observed

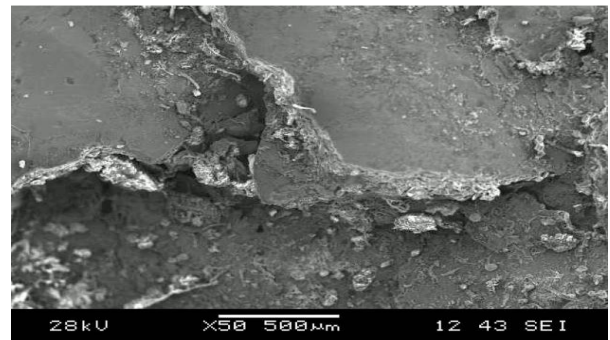
Fig. 18- SEM view of the bearing. Cleavage fracture observed

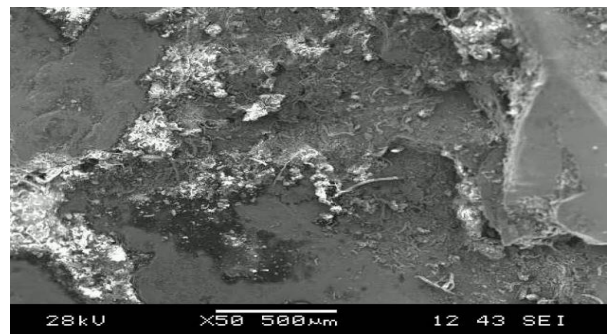
The fractured bearing was cleaned ultrasonically using acetone, and examined under SEM and the outcome of the investigation are shown in Figs. 16, 17, 18 and 19. No surface preparation and coating were done on the surface of the bearing components during an examination. Furthermore, an accelerating voltage of 25 kV was applied during the SEM analysis. Wear debris and corrosion products (Fig. 16) were seen on the surface of the rollers as well as on the races of the bearing due to the presence of some kind of corrosive and wear elements in the gearbox oil. The mode of failure of bearing is fatigue and cleavage fracture (Figs. 17 and 18) because of high cyclic fatigue phenomenon. Fig. 19 shows the SEM image of the bearing with high cyclic fatigue and brittle fracture

Fig. 19- SEM view of the bearing. High cycle fatigue and brittle fracture observed

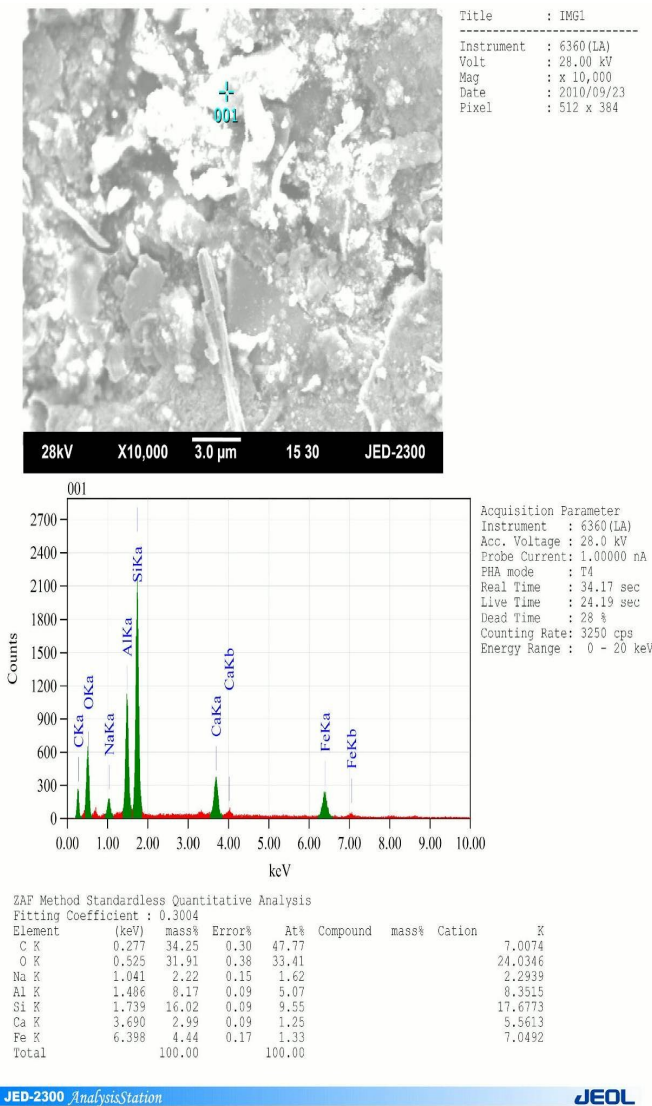
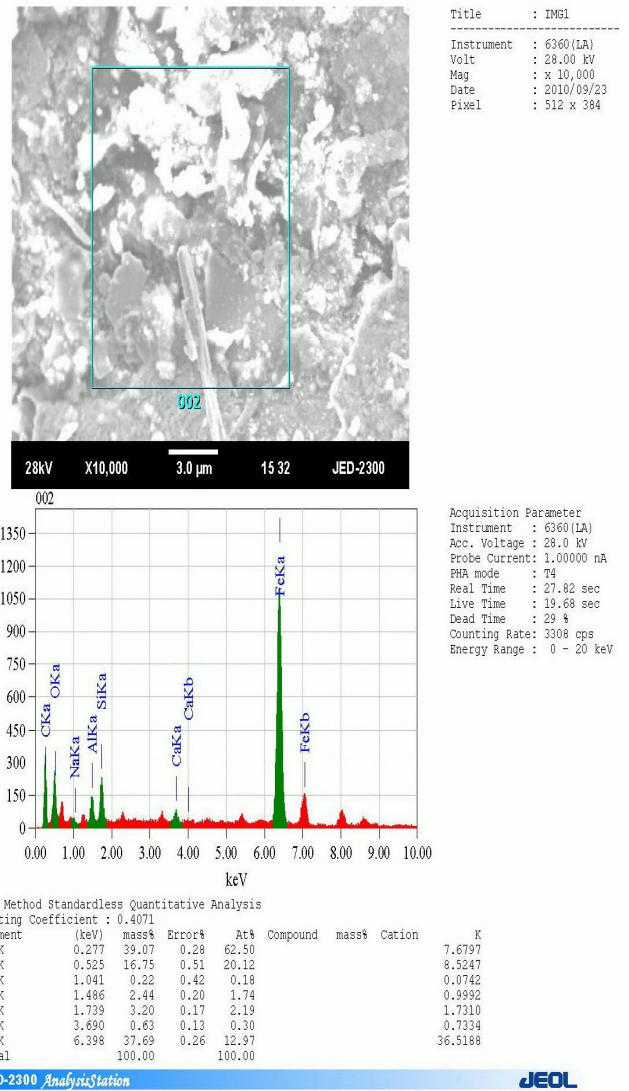
The damaged bearing was examined under Energy Dispersive X-ray Spectrometer (EDS) and the outcome of the investigation is illustrated in Figs. 20 and 21. Further, an accelerating voltage of 28 kV and probe current of 1.00000 nA were applied during the examination. In the EDS report, the horizontal and vertical axes represent the energy range (0 to 20 keV) and the counting rate (max 3250 cps) respectively. The bauxite elements observed in the first sample ( Fig. 20) were sodium (Na), aluminium (Al) and silicon ( Si) . The percentage of mass of silica was prominent (16.02 %) at 1.739 keV followed by Alumina ( 8.17 %) at 1.486 keV and sodium 2,22 % at 1.041 keV. Similarly, there were three bauxite elements viz, sodium, alumina and silicon were observed in the second sampling (Fig.21). In this case also, the percentage of mass of silicon was on the higher side ( 3.20 %) at 1.739 keV energy range. From the EDS study, it was evident that the presence of bauxite particles in the gearbox oil is due to the wear of gear and bearing. The bauxite will lead to excessive material removal during peak power generation on the rollers as well as on the races of the bearing.
